Portage Creek Sediment Remediation Project Kalamazoo, Michigan

Pre-Sediment Removal Structure Feature Assessment Removal Area SA6

F&V Project Number: 809930
April, 2012

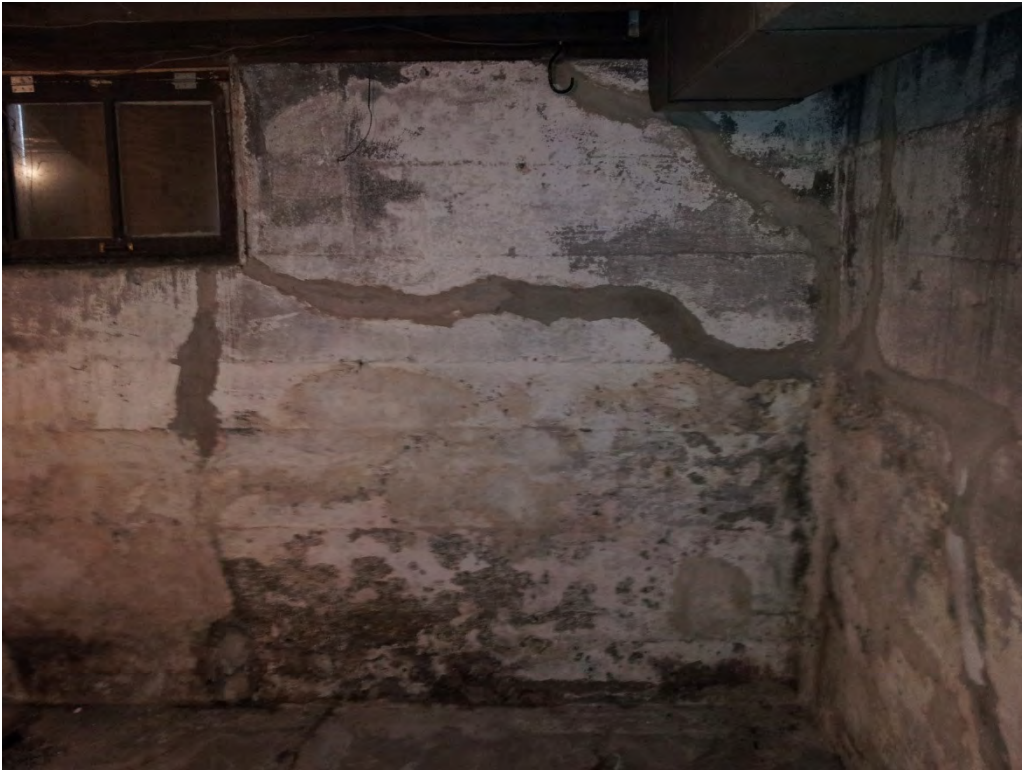
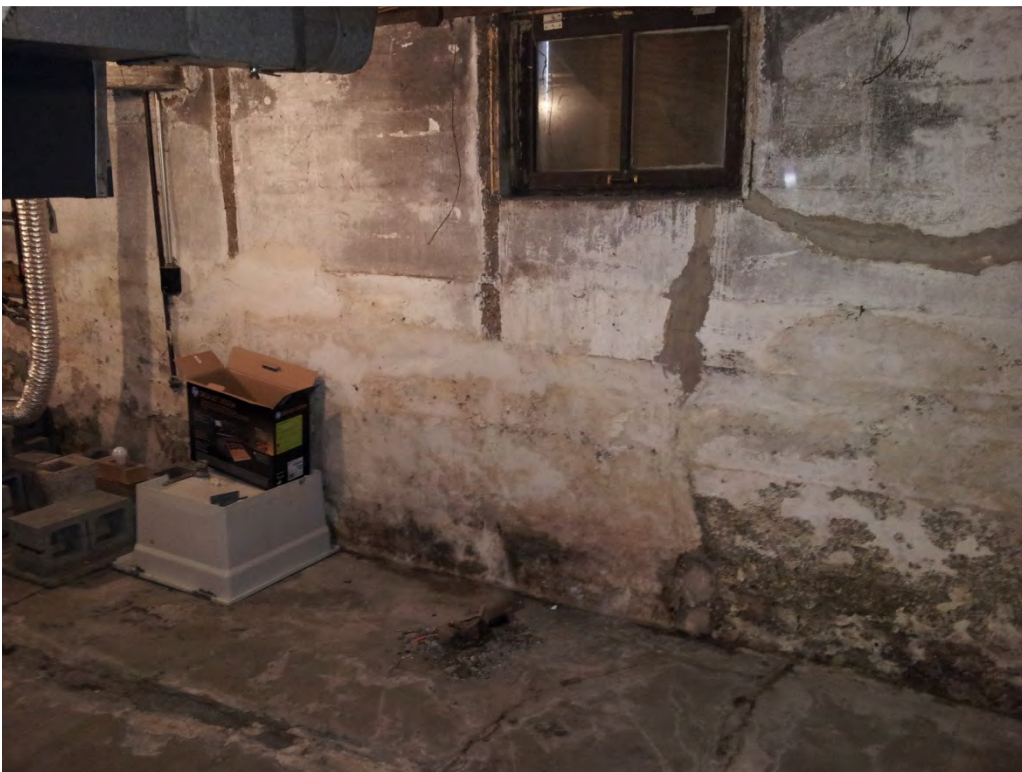
- The fence is leaning severely in the area of the gate and has a missing section just south of the gate.
- The bank along the property has been cleared. It is very steep, near vertical in places, and undercut approximately 12 inches with exposed roots throughout.
- The current resident indicated that the basement area routinely floods with about 4 feet of standing water. The elevation of the basement floor slab appears to be at or near the normal water surface of the creek. The sump pump crock had standing water just below the floor slab at the time of the review.
- The concrete floor slab in the basement has severe cracking and heaving throughout, with prior grout seal and re-cracking. The west foundation wall has vertical, horizontal and diagonal cracking with grout seal and re-cracking. Cracking in the wall appears to concentrate around the window penetrations.

Cracking in west concrete foundation wall

- We understand that the fencing will be removed by the current resident. It should be replaced in kind after sediment removal operations at the discretion of the property owner.
- The foundation of the home appears to be of sufficient depth and distance from the excavation area that it will not require special protection. However, because the foundation is severely deteriorated, vibration from cofferdam installation could impact the structure. Therefore, it may be advisable to monitor vibration near the structure to supplement this report should a claim arise.

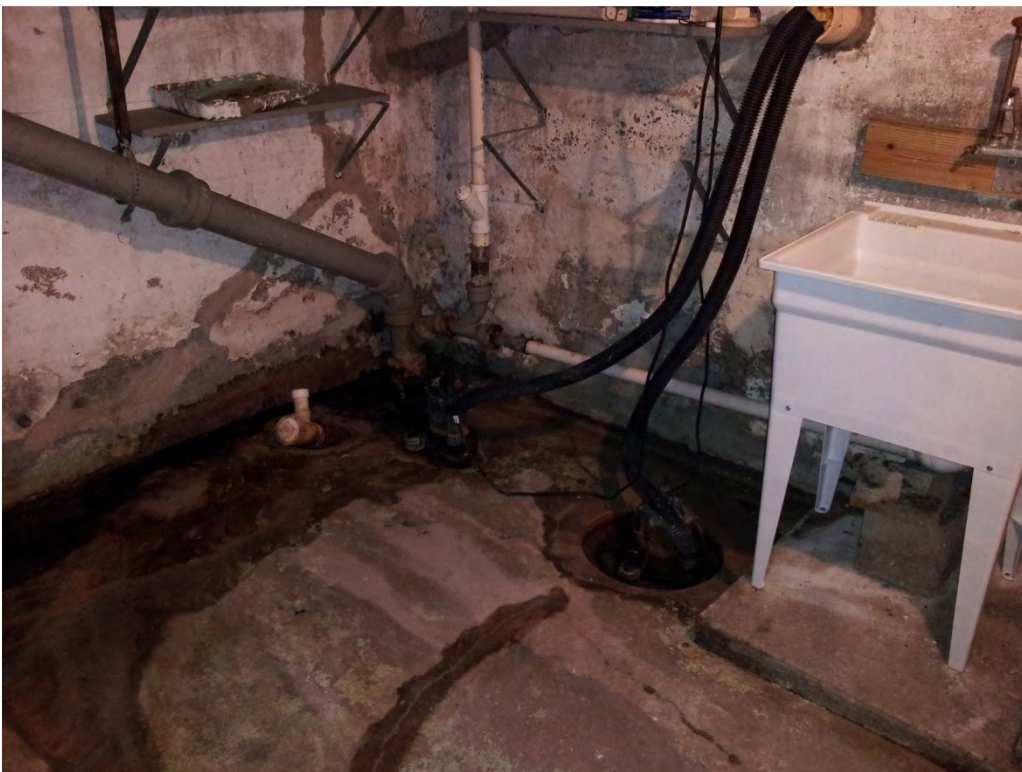
Sump pumps in southwest corner of basement

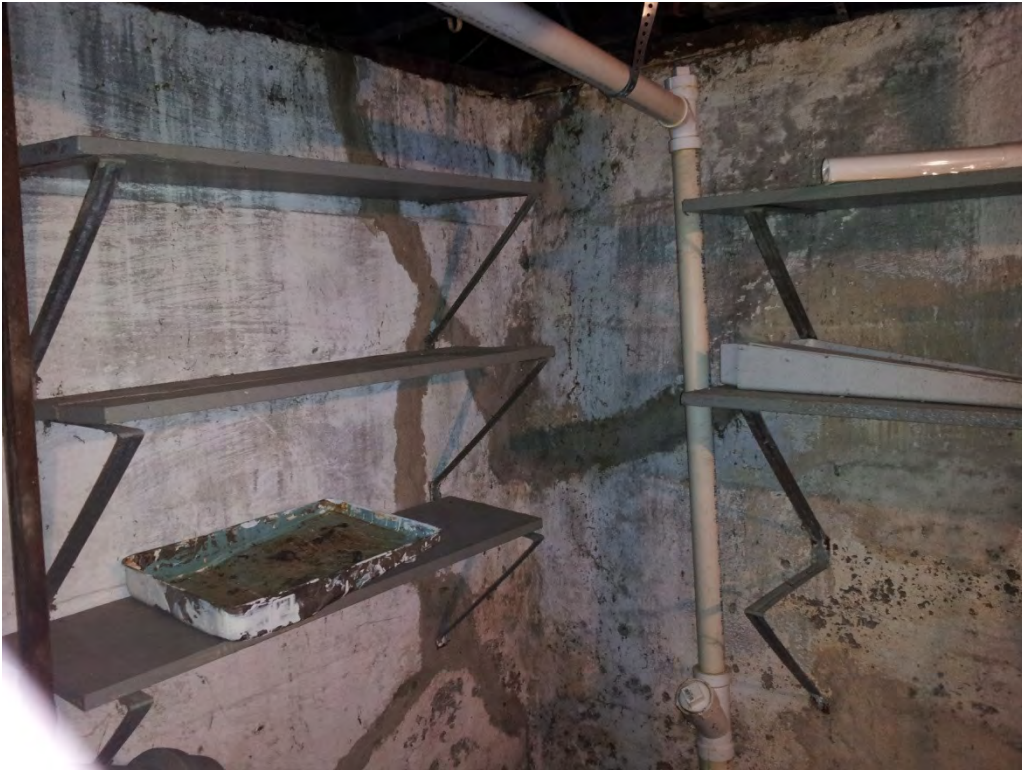
Cracking in southwest foundation wall

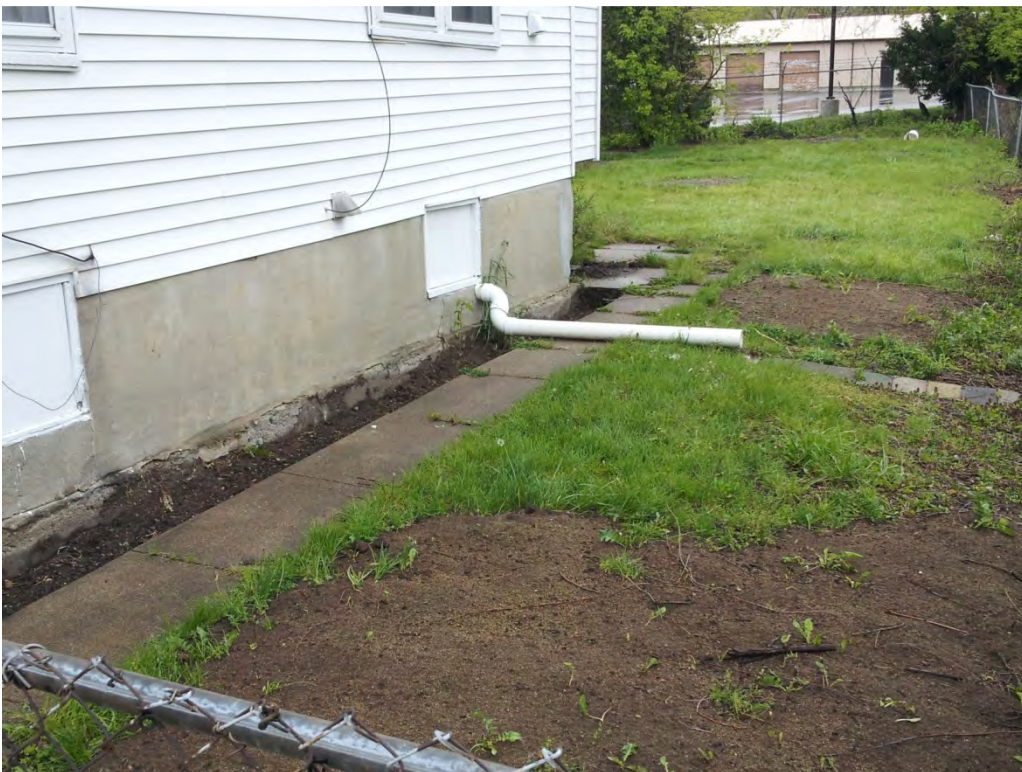
Sump pump outlet pipe

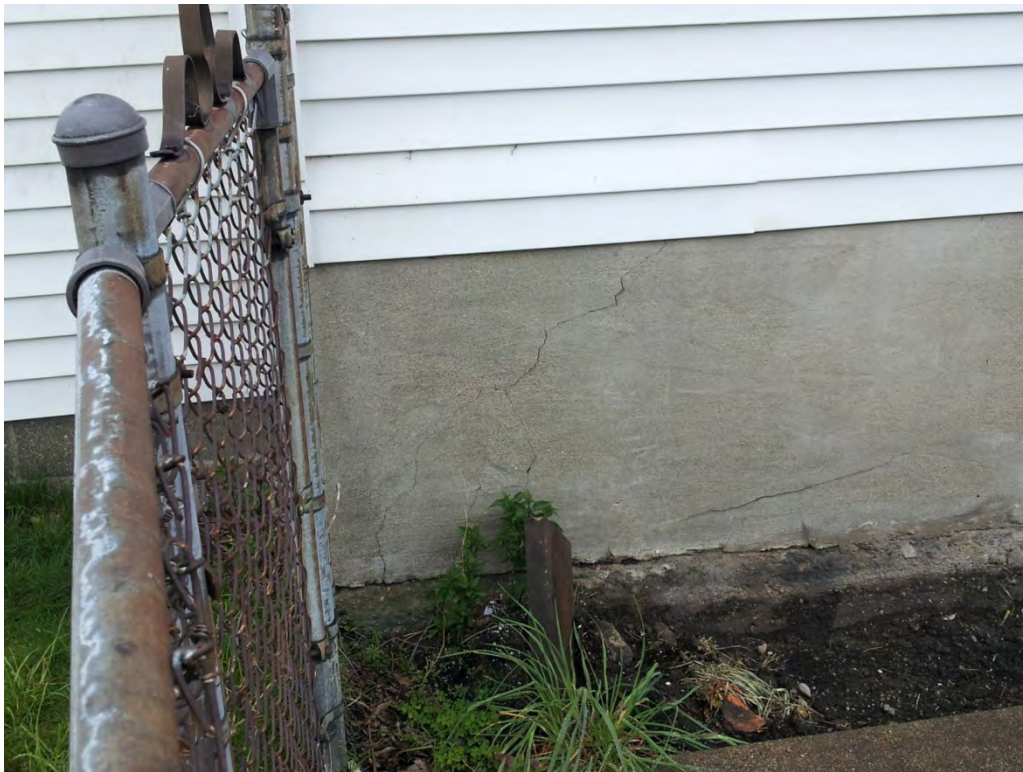
Cracking in foundation wall reflecting through newer coating

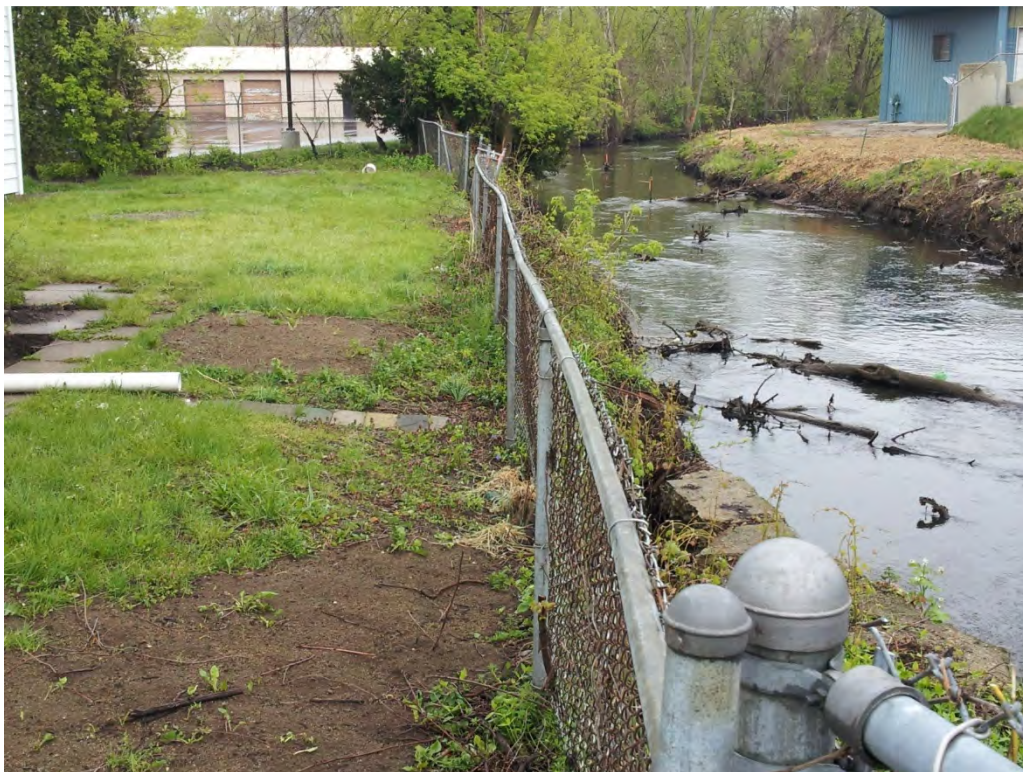
View of fence from top of bank

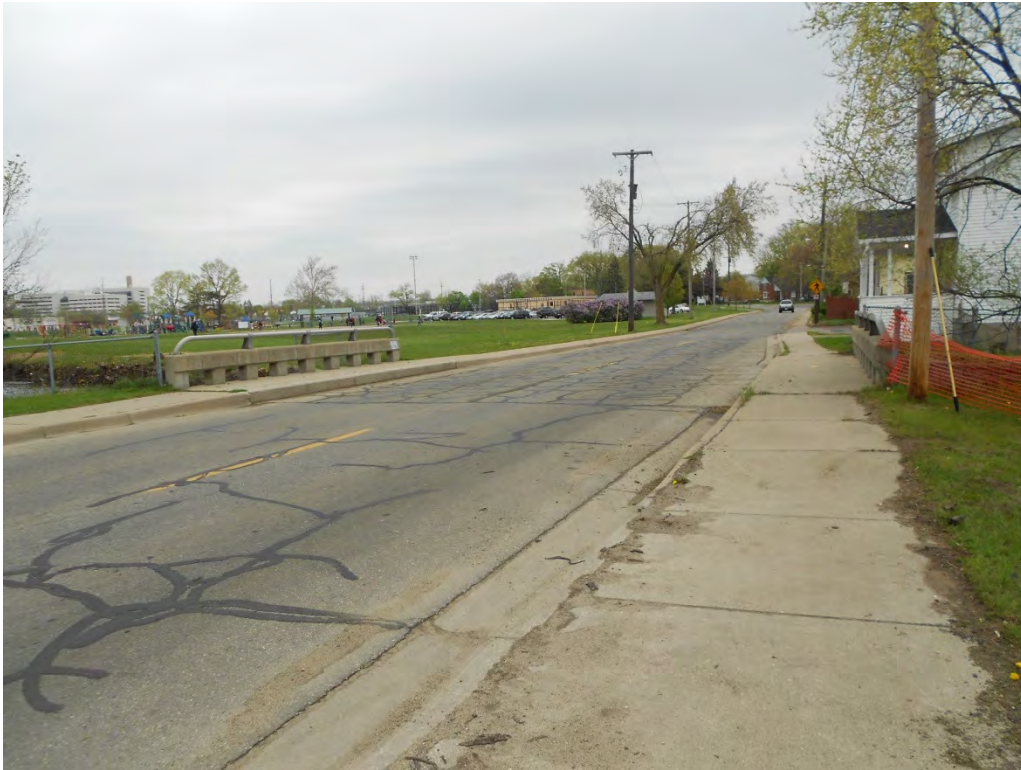
View of the structure from the approach area

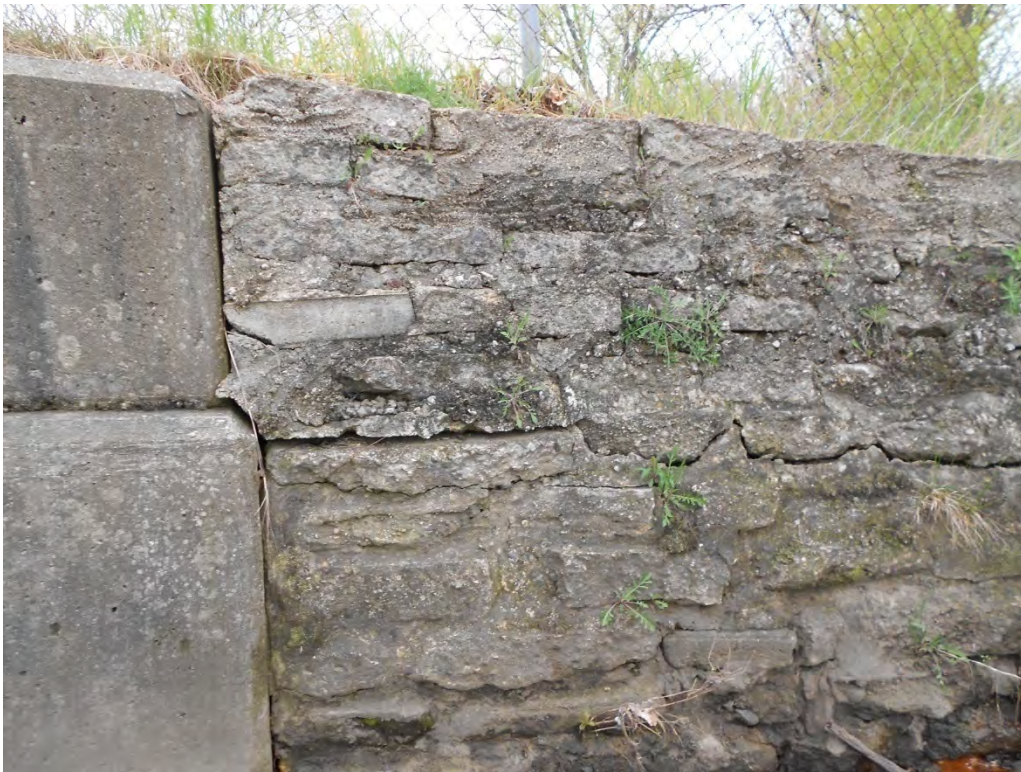
Cracking in the northwest concrete block wingwall

- The primary structure is north of the cofferdam limits for SA6 and is founded on piles. Therefore, no special protective measures are anticipated. However, the northernmost cofferdam is located within the concrete block wingwalls in the southeast and southwest. It is recommended that a U-shaped cofferdam be created to allow the cofferdam to be extended into the banks south of the wingwalls and avoid undermining the walls during sediment removal. The cofferdam should be placed with a minimum 4' clearance to the walls.

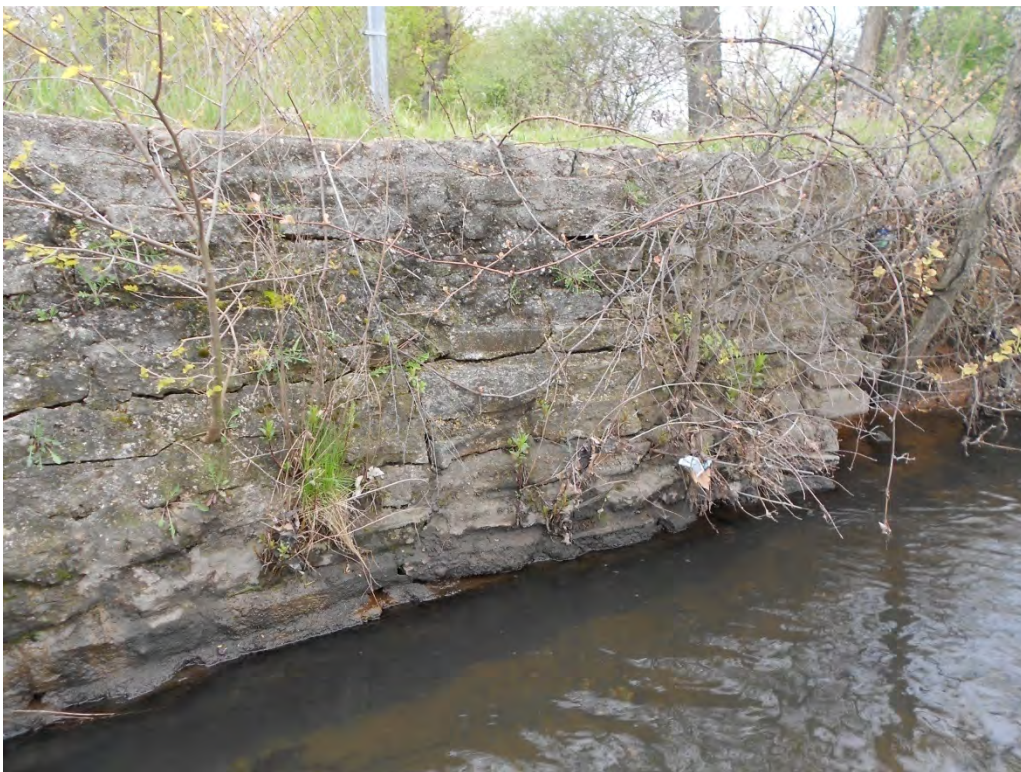
Cracking and vegetation growth in the northwest wingwall

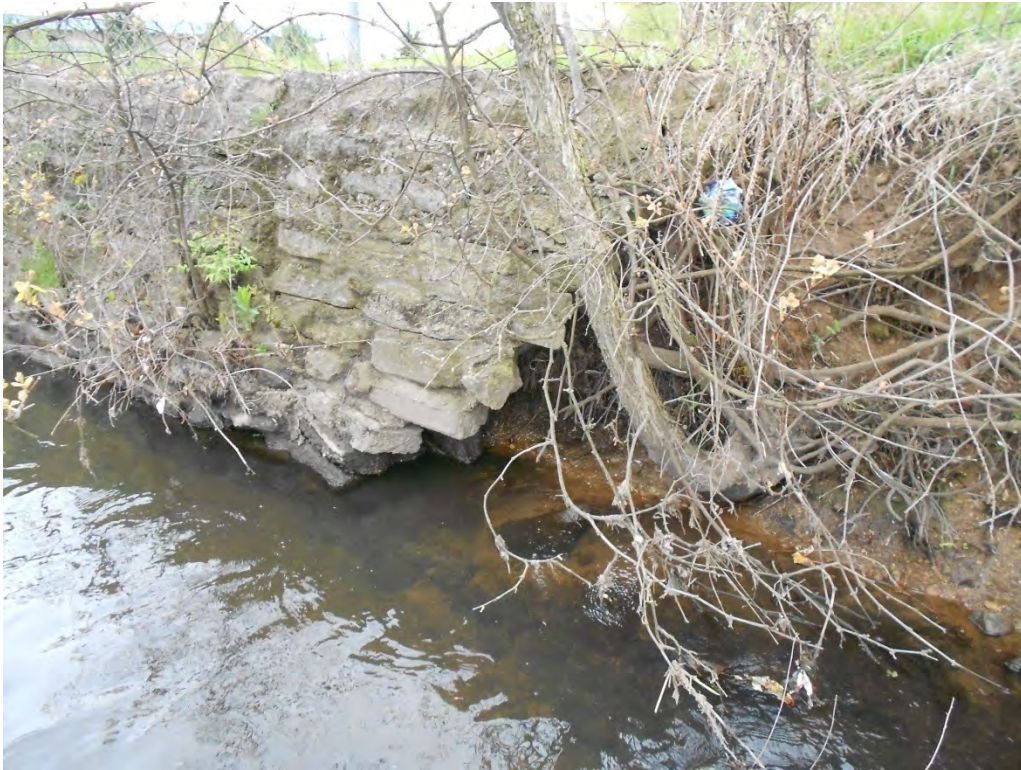
- The southwest wingwall extension is made of concrete rubble supported by fence posts. It is severely undermined with bank undercut approximately 2-3 feet. The original concrete block wall in the southwest has tree growth behind, mortar gaps and 1/2"-1" gap to the concrete curtain wall. The concrete block wall in the northwest has 1/4"-1/2" gap to the curtain wall and severe horizontal cracking approximately mid-height. It also has severe bank erosion and undermining around the end. The concrete block wall in the northeast has moderate bank erosion and undermining around the end with a failed block at the waterline. There is scattered cracking in the wall and 1/8"-1/4" gap to the curtain wall. The concrete block wall in the southeast has 1/8"-1/4" gap to the curtain wall, moderate to severe horizontal cracking approximately mid-height and scattered moderate to severe vertical cracking. The south end is failing from severe bank erosion and undermining with material behind the wall settling.

Severe bank erosion and undermining around the end of the northwest wingwall

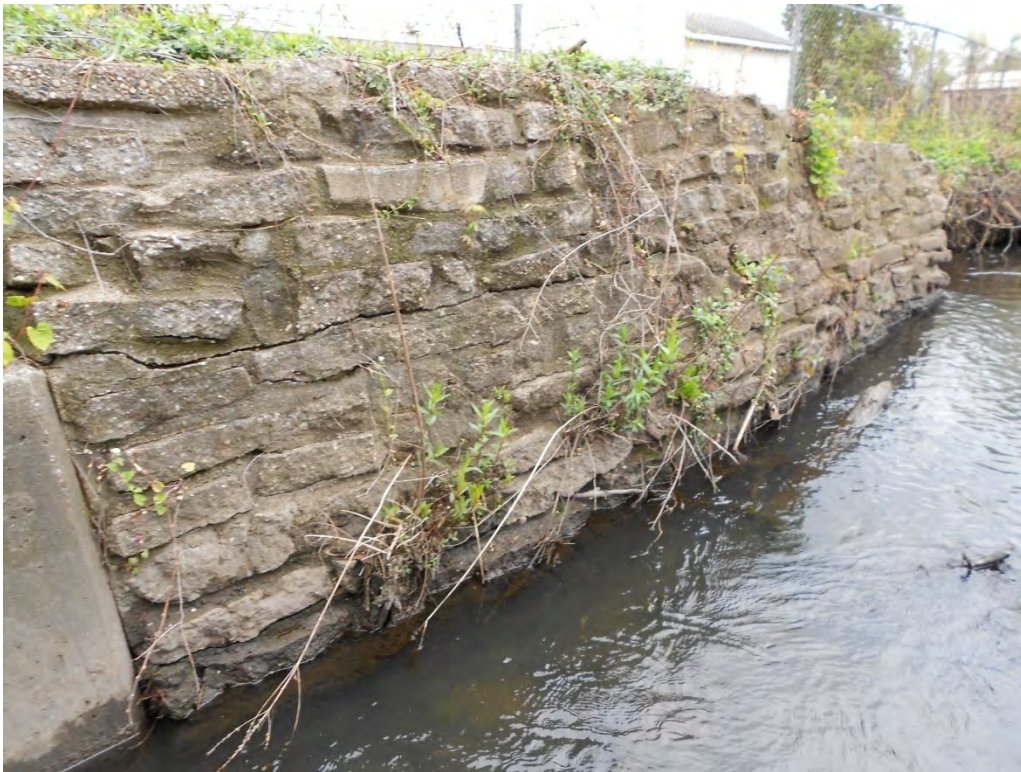
Cracking in the southeast concrete block wingwall

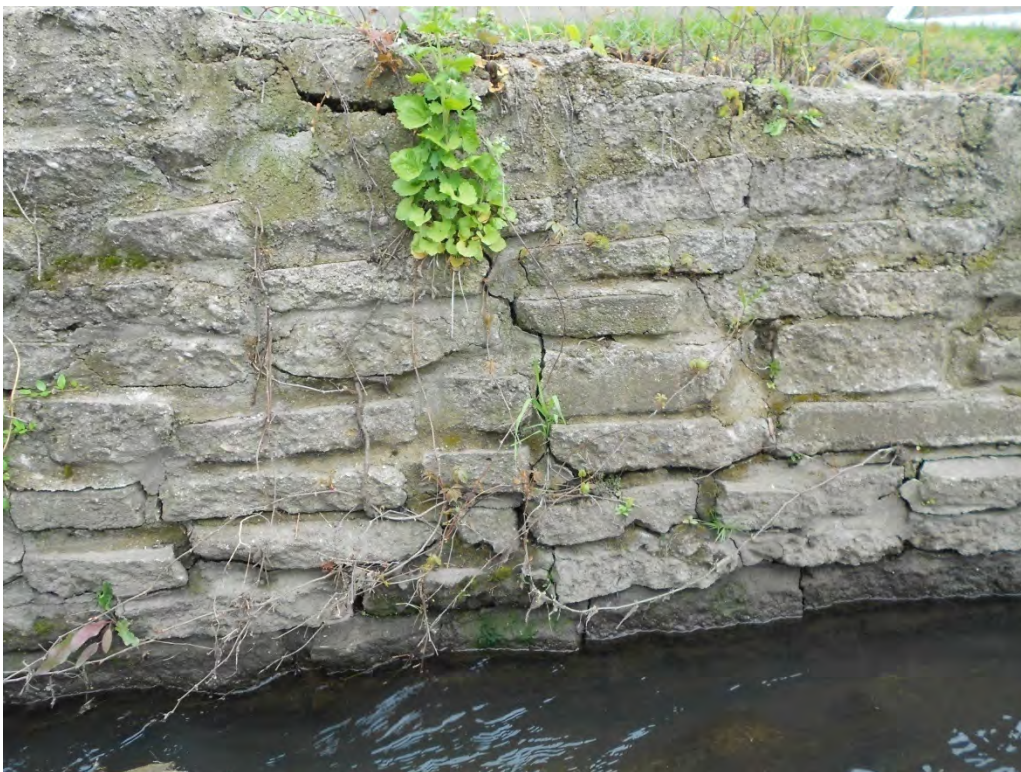
Cracking and vegetation growth in the southeast wingwall

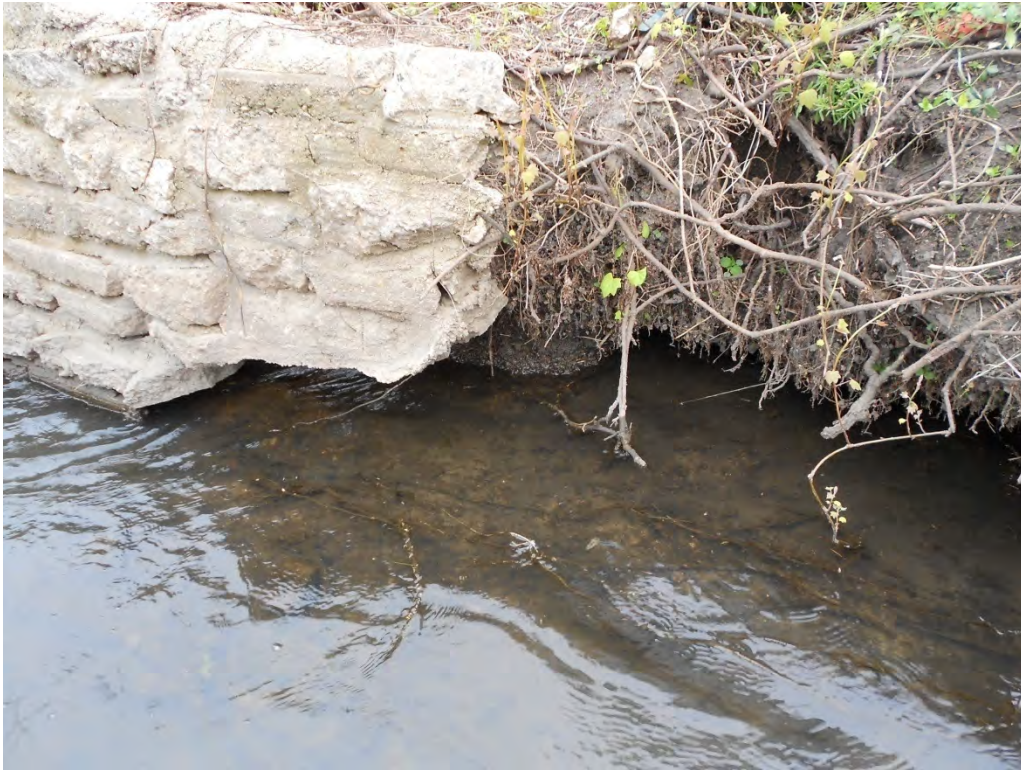
Severe bank erosion and undermining around the end of the southeast wingwall

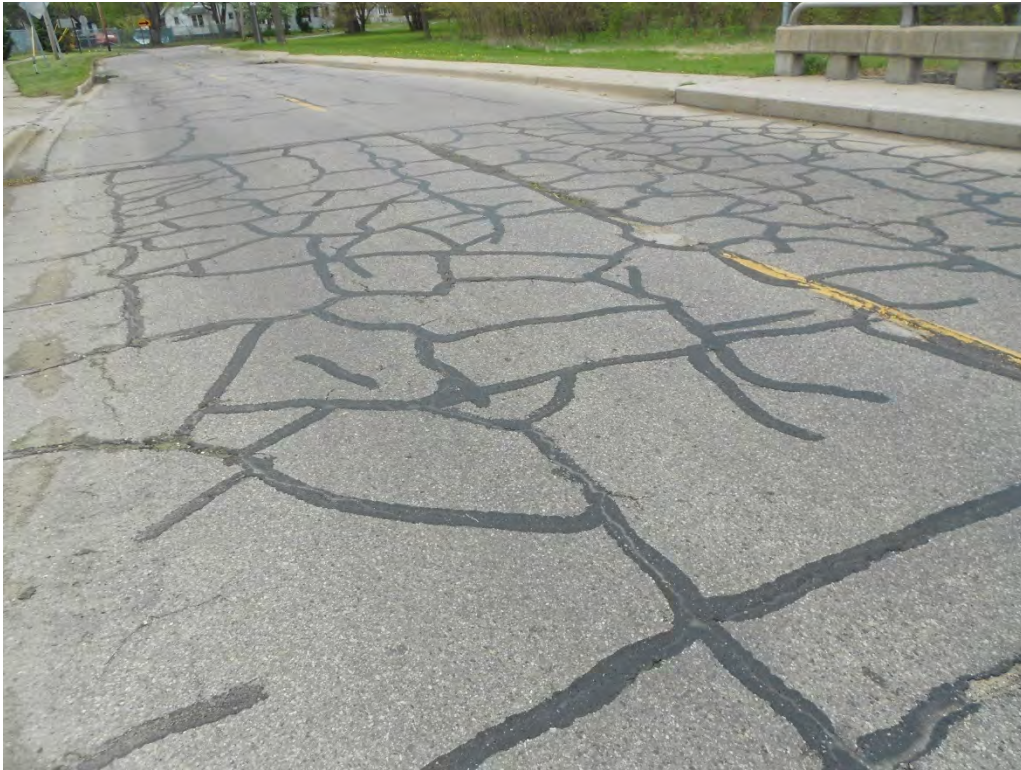
- The asphalt approach pavement has longitudinal and transverse cracking at 2-10 foot spacing on the west and 2-4 foot on the east, which is mostly sealed. The asphalt surface has map cracking throughout at 1-2 foot spacing, which is mostly sealed. There is spalling and cold patch along centerline. Severe transverse cracking and spalling with cold patch was noted along the reference lines.

Cracking in the asphalt surface area

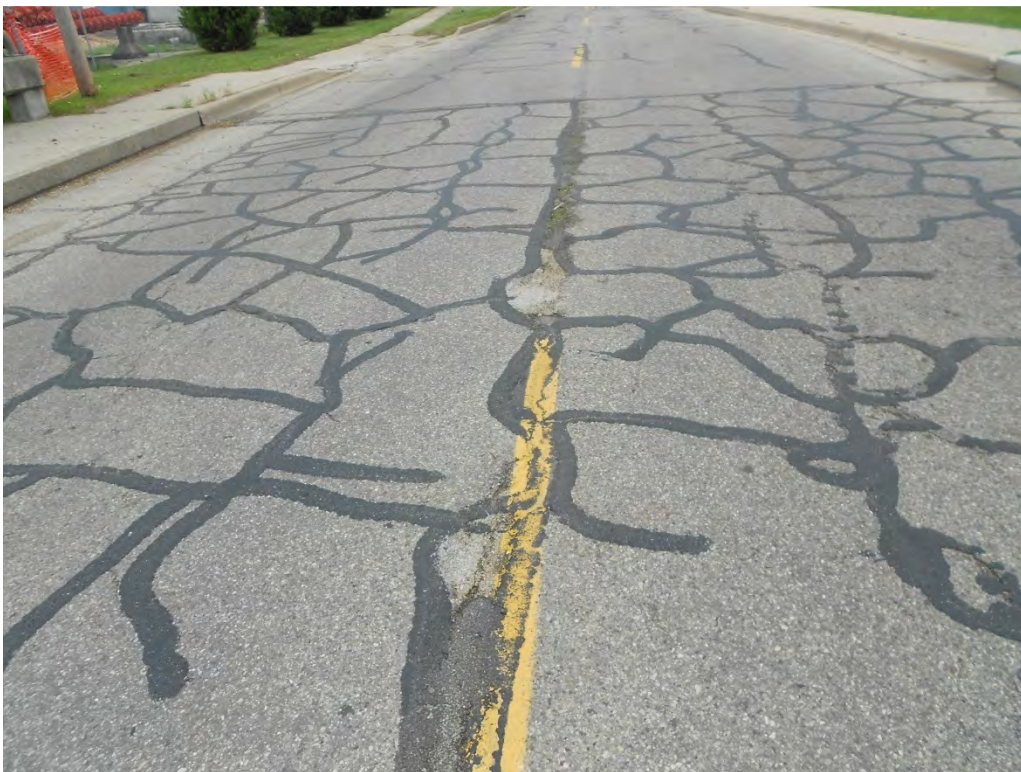
Cracking and cold patch in the asphalt surface along centerline
